- Implementation Limits from US 70 to SR 1617
 - Part A US 70 to SR 1614 (1.70 Miles) Both Shoulders
 - Part B SR 1614 to SR 1617 (1.23 Miles) Southern Shoulder
 - Completed August 20, 2008
 - Part of Resurfacing
 - After September 2010 (~ 24 Months)
 - Cross Section 1

• Observation – During Installation

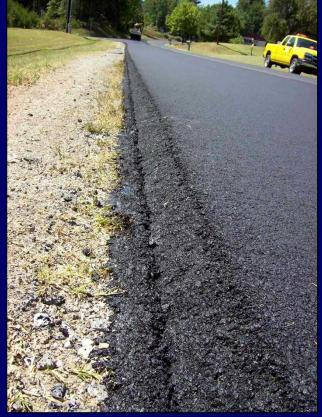
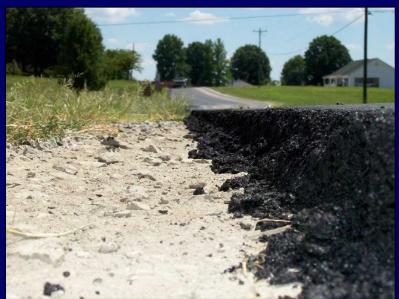
Without Safety Edge

With Safety Edge

The photos above were taken during implementation on Part B of the resurfacing project. The left side is WITH Safety Edge (southern shoulder), the right side is WITH OUT Safety Edge (northern shoulder). Notice the 30 degree shaped and formed pavement edge (safety edge) in the photo on the left. Notice the 60-90 degree with a non-shaped and non-formed pavement edge (standard edge) that crumbles and breaks off in the photo on the right.

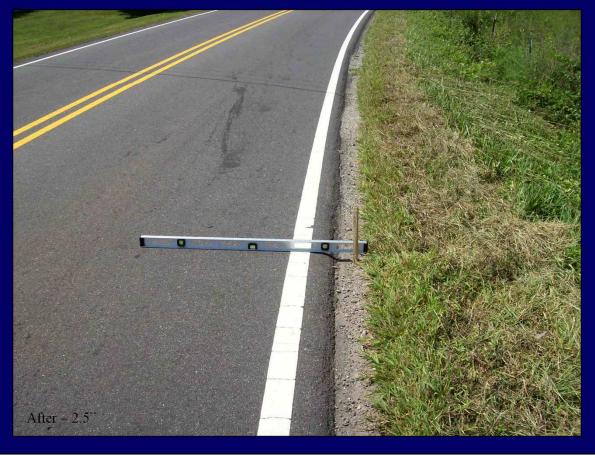
Observation of Site A – Safety Edge

The photo above was taken at the $^{\sim}24$ month time period after implementation of the resurfacing project. Notice how the shoulder has re-rutted back out, but the safety edge is holding up to traffic. This site measured as 2.5 inch drop-off.

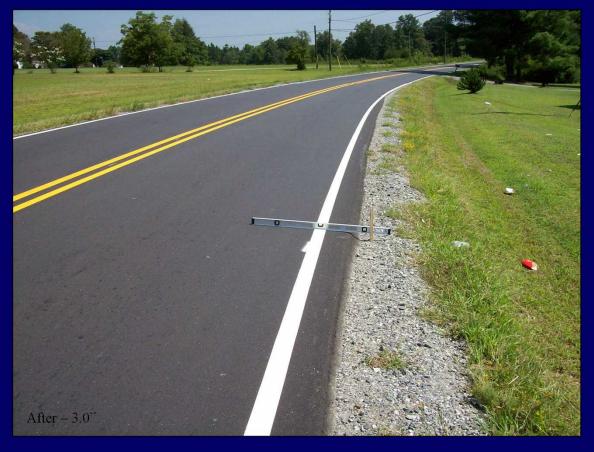
Observation of Site B – Safety Edge

The photo above was taken at the $^{\sim}24$ month time period after implementation of the resurfacing project. Notice how the shoulder has re-rutted back out, but the safety edge is holding up to traffic. This site measured as 3.0 inch drop-off.

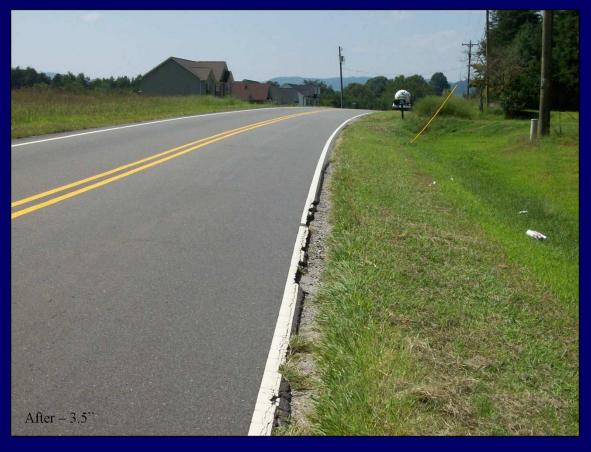
Observation of Site C – Standard Edge

The photo above was taken at the $^{\sim}24$ month time period after implementation of the resurfacing project. Notice how the shoulder has re-rutted back out, but the standard edge is NOT holding up to traffic. This site measured as 3.5 inch drop-off.

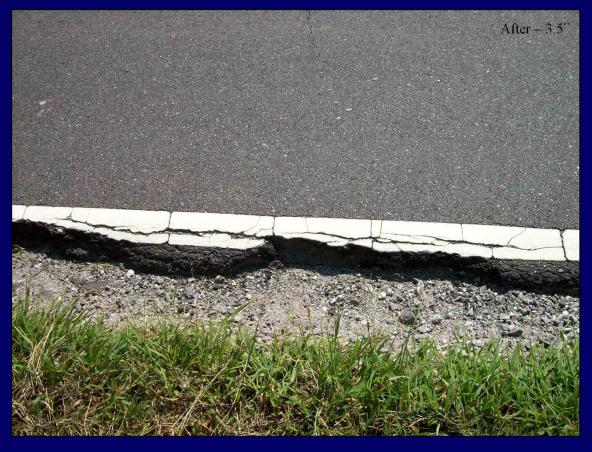
Observation of Site C – Standard Edge

Close-up. The photo above was taken at the $^{\sim}24$ month time period after implementation of the resurfacing project. Notice how the shoulder has re-rutted back out, but the standard edge is NOT holding up to traffic. This site measured as 3.5 inch drop-off.
